ANALYSIS OF ENGINE PYLON STRUCTURAL FAILURE AND ITS IMPACT ON FLIGHT SAFETY: CASE STUDY OF MD-11F (N259UP)

ABSTRACT— This study aims to analyze the catastrophic structural failure experienced by a UPS McDonnell Douglas MD-11F (N259UP) cargo aircraft on November 4, 2025, in Louisville, Kentucky. The investigation focused on the detachment of the number 1 engine due to engine pylon failure during takeoff. Through metallurgical analysis and a review of the NTSB investigation report, fatigue cracking in the forward mount fitting was found to be the primary cause of the engine detachment. The results revealed gaps in routine inspection methods for aging aircraft. The study concluded that transitioning to Structural Health Monitoring technology and fleet modernization are crucial risk mitigation measures for the global air cargo industry.

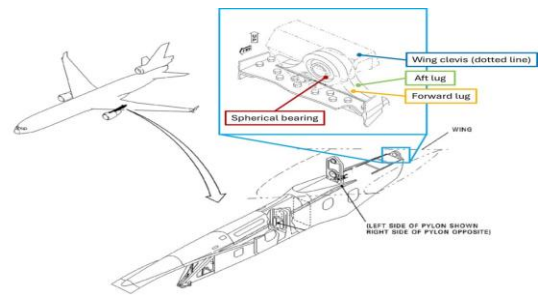
Technical Analysis: Engine Pylon Failure
The primary focus of the National Transportation Safety Board (NTSB) investigation was the pylon structure a component that serves as a mechanical bridge between the engine and the wing. On the MD-11, engines 1 and 3 are suspended below the wing using a highly complex mounting system. Metallurgical analysis of the wreckage of N259UP revealed fatigue cracking in the forward mount bolt and pylon fitting. These cracks did not occur suddenly, but rather resulted from the accumulated stress of thousands of flight cycles over the aircraft's 30-year lifespan. This phenomenon was exacerbated by the MD-11's structural design, which has specific dynamic load characteristics in the pylon area. When the cracks reached a critical point, the structure could no longer withstand the thrust and weight of the engines, causing the engines to completely separate from the fuselage (detachment).

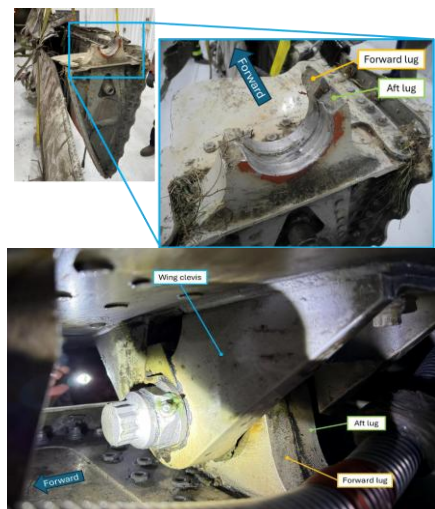
- **Fitting Component:** Consists of a "U" or "I" shaped bracket secured with high-tensile bolts.
- **Stress Concentration Point:** The sharp corners or bolt holes in this fitting are areas where stress accumulates. Investigations indicate that the crack originated from one of these bolt holes.

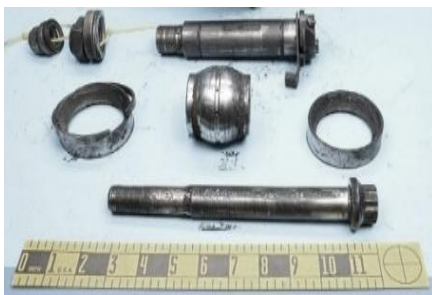
- **Initiation:** Due to the aircraft's age of 34 years, thousands of takeoff and landing cycles (during which the engines are operating at maximum capacity) created microscopic cracks in the metal surface.
- **Propagation:** Each time the aircraft flies, air pressure and engine vibrations gradually widen these cracks.
- **Catastrophic Failure:** When the remaining area of metal is too small to support the load, it fractures suddenly without warning (brittle fracture).
