Jurnal TNI Angkatan Udara Patriot Biru (Vol. 5 No. 2, 2026)
ISSN: 2809-5464

ANALYSIS OF ENGINE PYLON STRUCTURAL FAILURE AND ITS IMPACT ON FLIGHT SAFETY:CASE STUDY OF MD-11F (N259UP)

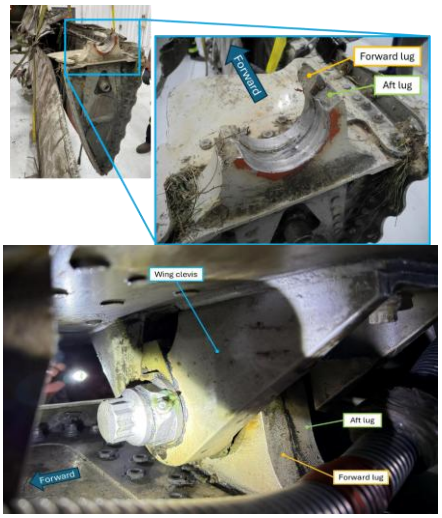
3.1. Anatomy of the Forward Mount (Primary Failure Point)

On the MD-11, the number 1 engine (left wing) is suspended from several primary support points. The Forward Mount is the most heavily loaded component because it must transfer thrust from the engine to the wing structure.

- *Fitting Component: Consists of a "U" or "I" shaped bracket secured with high-tensile bolts.*
- *Stress Concentration Point: The sharp corners or bolt holes in this fitting are areas where stress accumulates. Investigations indicate that the crack originated from one of these bolt holes.*

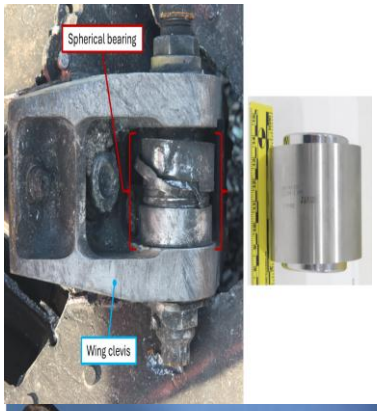
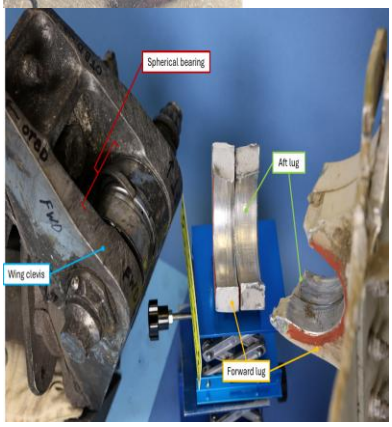
3.2. Fatigue Propagation Mechanism

Fatigue cracks are the primary enemy of aging aircraft. The process occurred in three stages in the case of N259UP:

- *Initiation: Due to the aircraft's age of 34 years, thousands of takeoff and landing cycles (during which the engines are operating at maximum capacity) created microscopic cracks in the metal surface.*
- *Propagation: Each time the aircraft flies, air pressure and engine vibrations gradually widen these cracks.*
- *Catastrophic Failure: When the remaining area of metal is too small to support the load, it fractures suddenly without warning (brittle fracture).*
