ANALYSIS OF ENGINE PYLON STRUCTURAL FAILURE AND ITS IMPACT ON FLIGHT SAFETY: CASE STUDY OF MD-11F (N259UP)

ABSTRACT— This study aims to analyze the catastrophic structural failure experienced by a UPS McDonnell Douglas MD-11F (N259UP) cargo aircraft on November 4, 2025, in Louisville, Kentucky. The investigation focused on the detachment of the number 1 engine due to engine pylon failure during takeoff. Through metallurgical analysis and a review of the NTSB investigation report, fatigue cracking in the forward mount fitting was found to be the primary cause of the engine detachment. The results revealed gaps in routine inspection methods for aging aircraft. The study concluded that transitioning to Structural Health Monitoring technology and fleet modernization are crucial risk mitigation measures for the global air cargo industry.

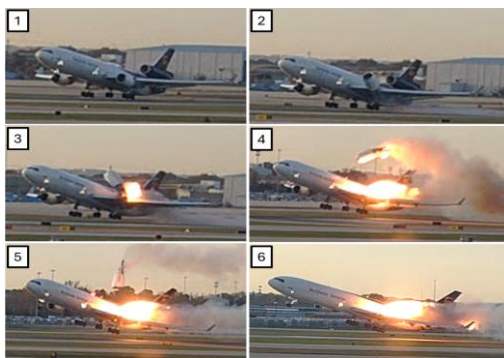
- **Location:** Louisville Muhammad Ali International Airport (SDF), Kentucky.
- **Incident:** An MD-11F cargo aircraft (registration N259UP) en route to Honolulu experienced a catastrophic mechanical failure during takeoff.
- **Engine Detachment:** The number 1 (left) engine and its pylon separated completely from the wing when the aircraft had only lifted appr

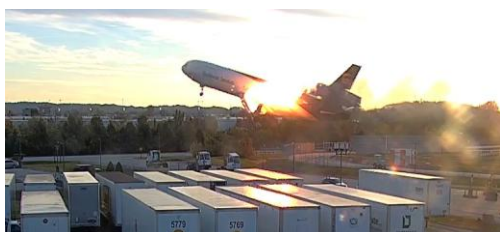
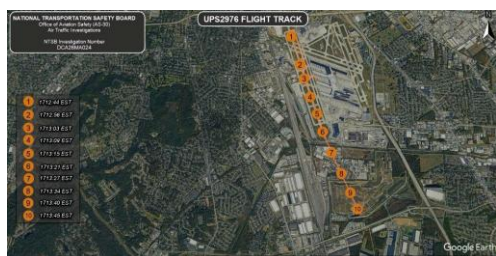
- **Impact:** The aircraft lost control, crashed into several industrial buildings (including a logistics warehouse and an oil recycling facility), and exploded in a large fireball due to its full fuel load.

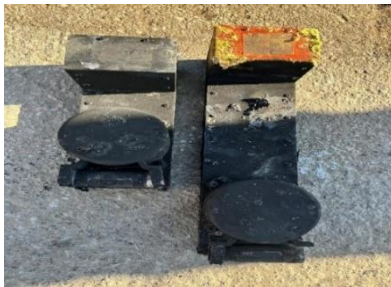
The NTSB investigation highlighted two important aspects: the effectiveness of the maintenance program and the manufacturer's technical history. Despite the aircraft having recently undergone a rigorous inspection, the cracks were not detected. This sparked debate about the current non-destructive testing methods used. Whether standard visual and ultrasonic methods are sufficient to detect cracks in the internal parts of the pylon, which is tightly enclosed by the fairing. Furthermore, preliminary reports indicate that there is historical data regarding potential weaknesses in the MD-11 pylon that have been known for decades. The failure to require component replacement (rather than simply inspection) is a crucial point in the liability analysis between the manufacturer and the aviation regulator (FAA)
